**OPPORTUNITIES FOR ECOLOGICAL IMPROVEMENT ALONG
THE LOWER COLORADO RIVER AND DELTA**

FINAL REPORT

**Prepared by:
Mark K. Briggs, Director of Research
Sonoran Institute, Tucson, Arizona**

July 24, 1997

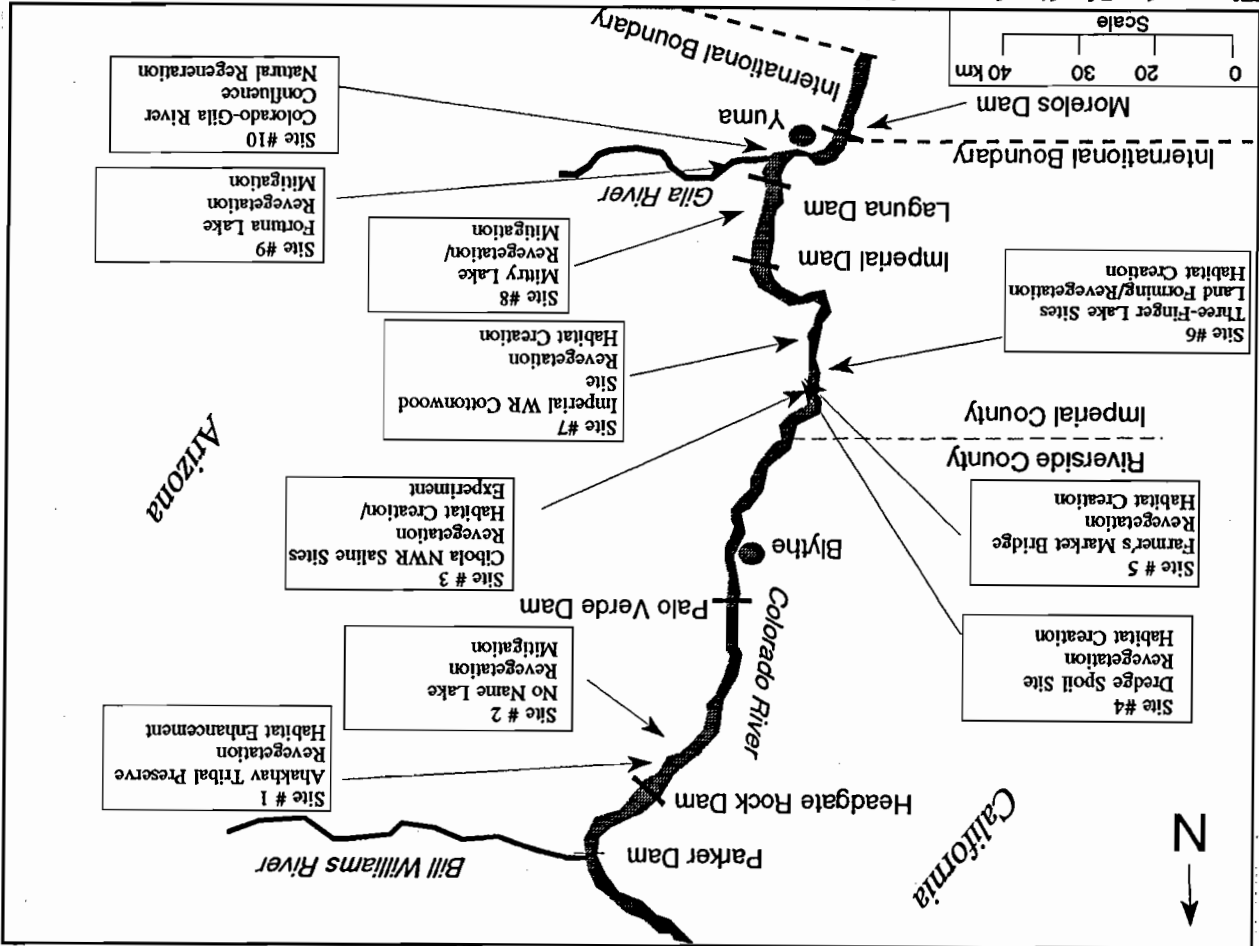
Figure 1. Idealized map of Colorado River mainstem from Parker Dam to the international boundary. Sites included in this investigation are labeled and their approximate location is indicated.

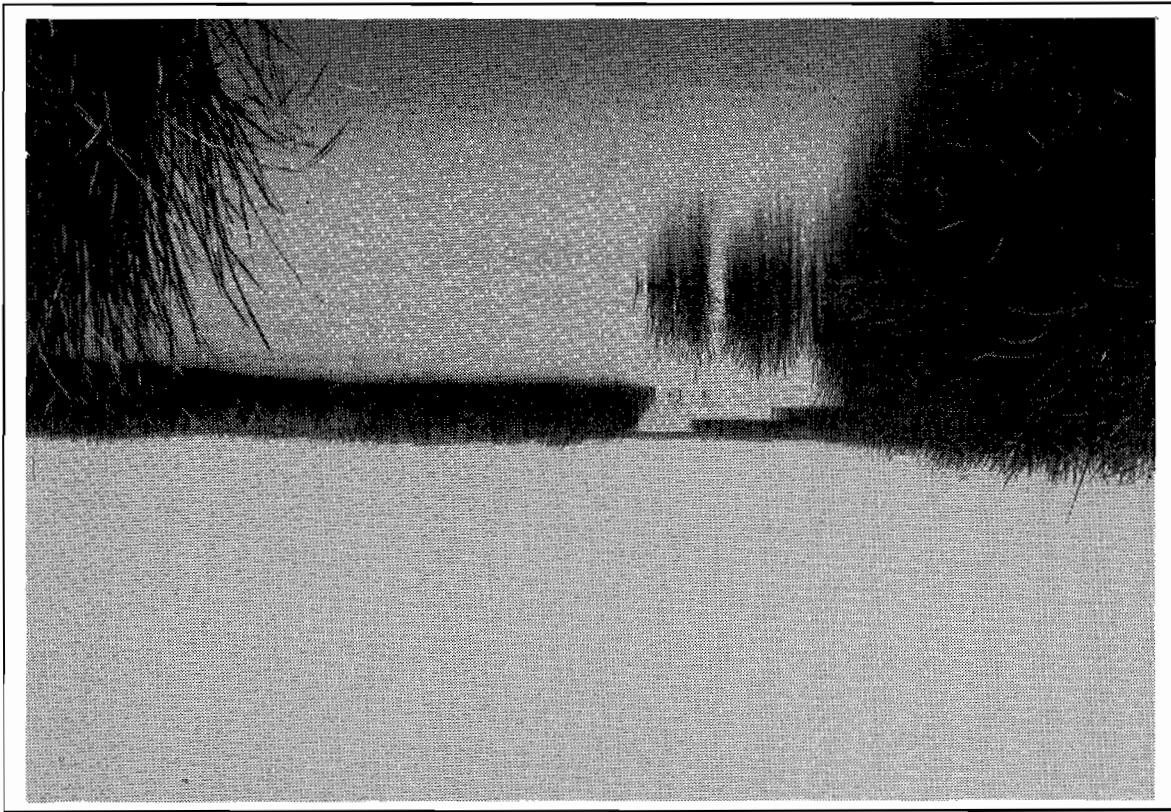
Figure 3. The Ciénaga de Santa Clara covers nearly 20,000 ha and provides critical habitat for a variety of wildlife species, including several species that are listed as endangered.

Conservation Challenges: The principal conservation challenge facing the ciénaga is the possibility that the Wellton-Mohawk canal will be turned off. The Wellton-Mohawk canal was planned as a temporary answer for agricultural wastewater deposition until the de-salinization plant went on line. Although the Santa Clara system is also

The Cienaga de Santa Clara exemplifies this priority. The cienaga is maintained for the most part by drainage flow from Arizona's Wellton-Mohawk canal. Since the canal's completion in 1978, the cienaga has grown from 200 hectares (estimated in 1973) to about 20,000 hectares (Glenn et al. 1996). As noted above, this cienaga offers habitat for many wildlife species, including probably the largest populations of the endangered Yuma clapper rails (Eddleman 1989; Abarca et al. 1993) and Sonoran desert pupfish (Hendrickson and Verela 1989; Abarca et al. 1993). If the Yuma desalting plant begins operation and the Wellton-Mohawk waters are diverted to irrigation districts in Mexicali, the largest remaining wetland in the region will be significantly compromised (Glenn et al. 1996; Zengel et al. 1995). Conservation efforts need to focus on ways to maintain flow into the Cienaga. If the desalting plant does go on line, other sources of water need to be found to make up for that lost to plant operations. Such alternative waters could be found by allocating Colorado River water for ecosystem maintenance or diverting agricultural return flows from Mexico southward.
